**The Comparison of Animal Detection Systems in a Test-Bed:
A Quantitative Comparison of System Reliability and Experiences
with Operation and Maintenance**

Final report

Federal Highway Administration

Montana Department of Transportation

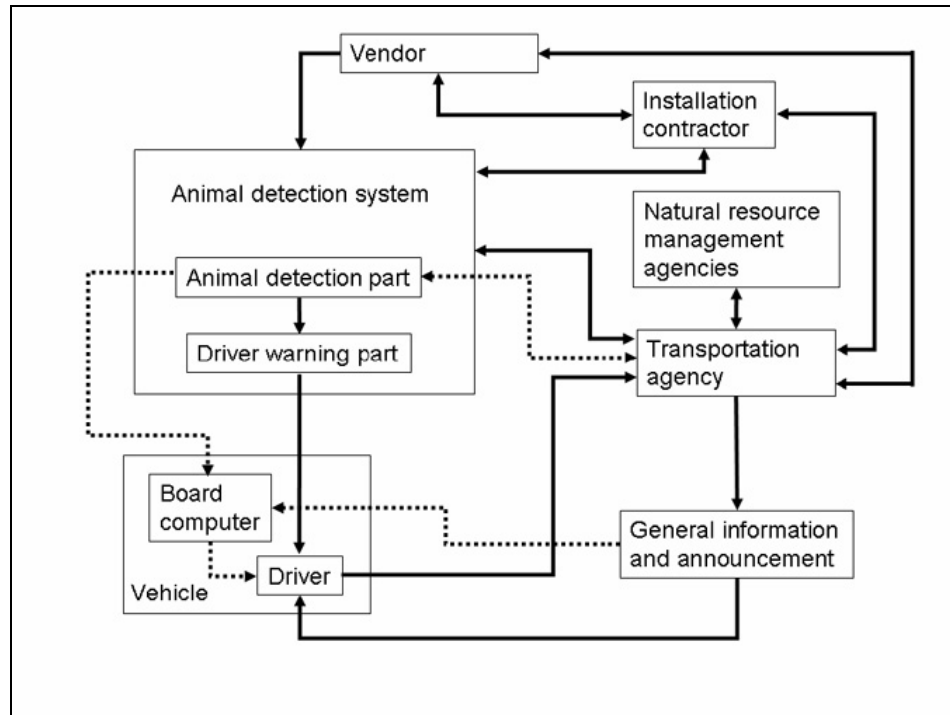
Figure 2.1: Concept of operations

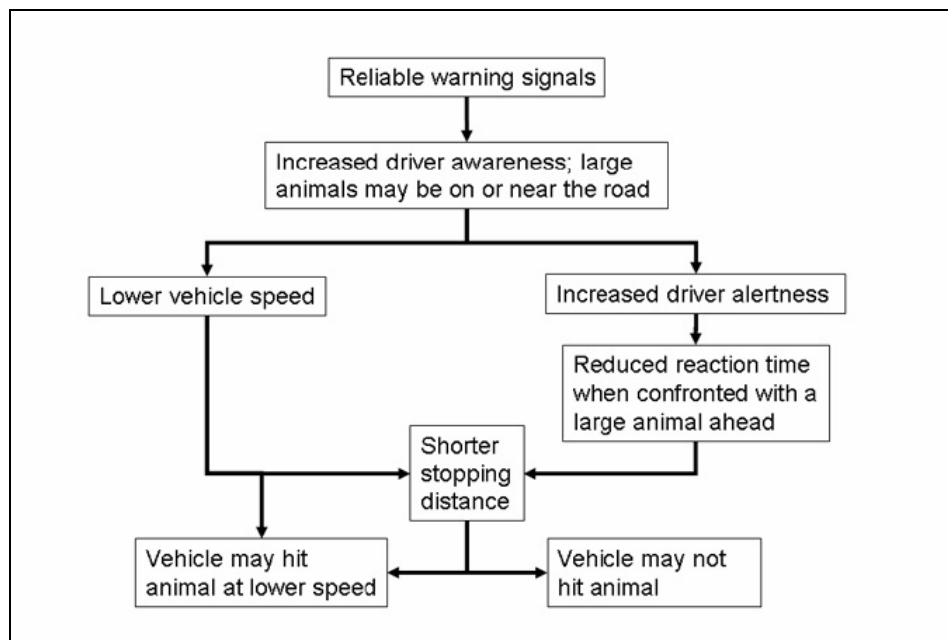
Figure 2.2: Warning signals and driver response

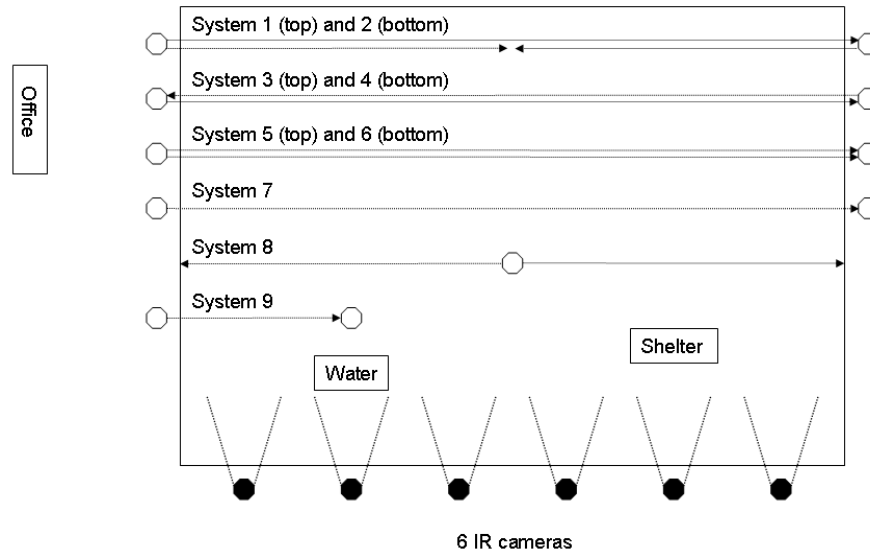
Figure 3.2: Test-bed design including an animal enclosure, the nine detection systems (open circles represent the sensors), the six infrared (IR) cameras aimed at the enclosure from the side (solid circles), and the office with data recording equipment. The arrows show the direction towards which each sensor or transmitter is pointed.

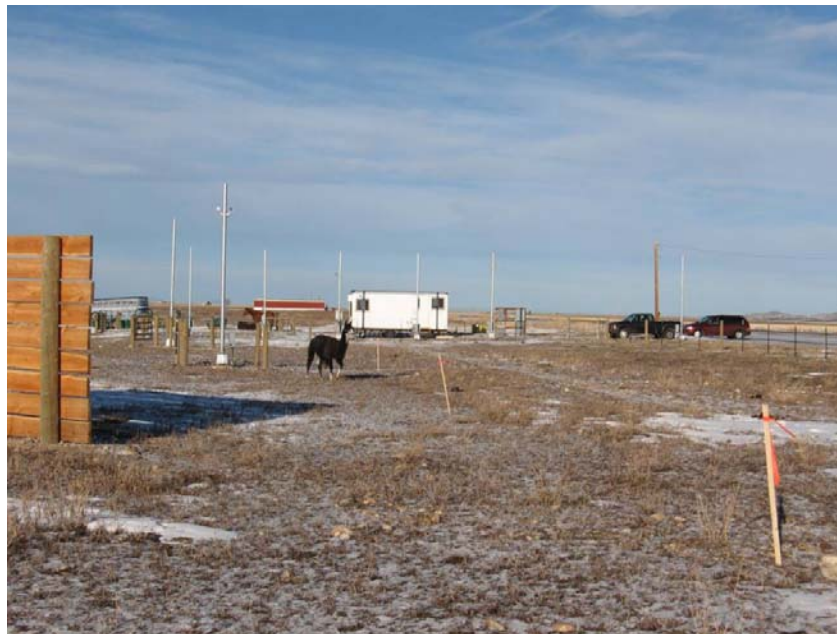
Figure 3.3: The test bed with the remote office, poles with animal detection systems attached to them, the shelter, and a llama (Photo: Marcel Huijser, WTI/MSU).

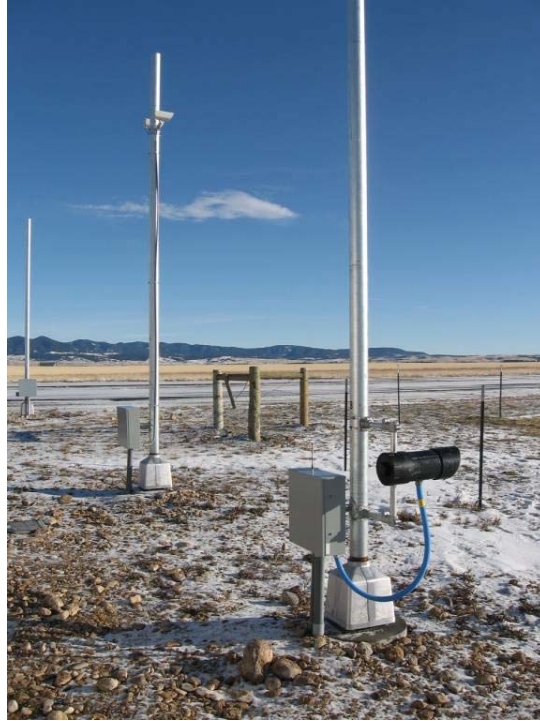
Figure 3.4: Some of the sensors of the animal detection systems (Photo: Marcel Huijser, WTI/MSU).

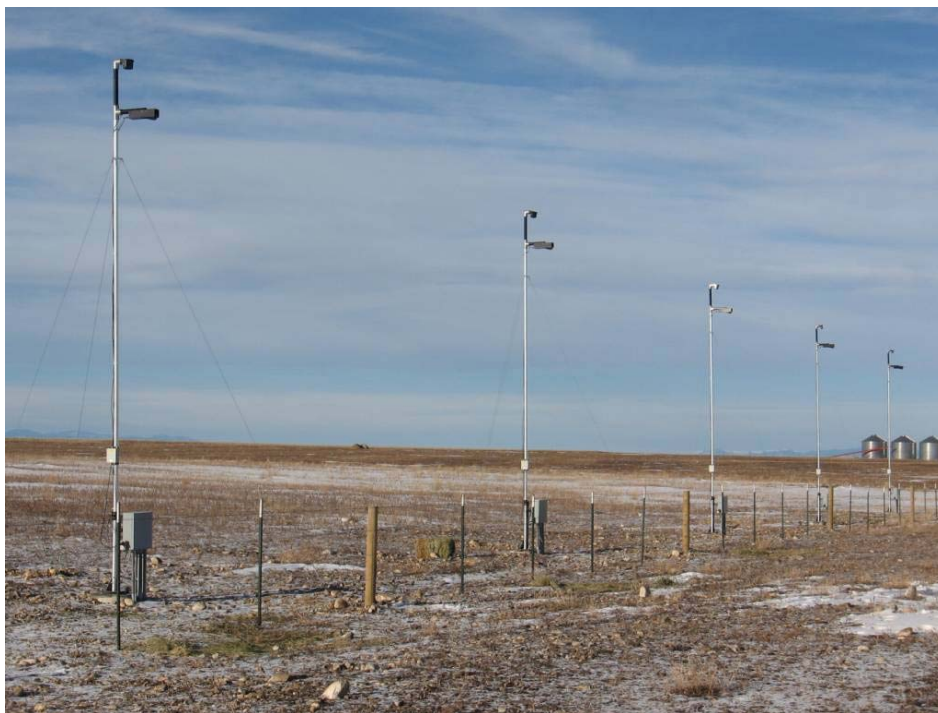
Figure 3.5: The infrared cameras that monitor animal movements in the enclosure (Photo: Marcel Huijser, WTI/MSU).

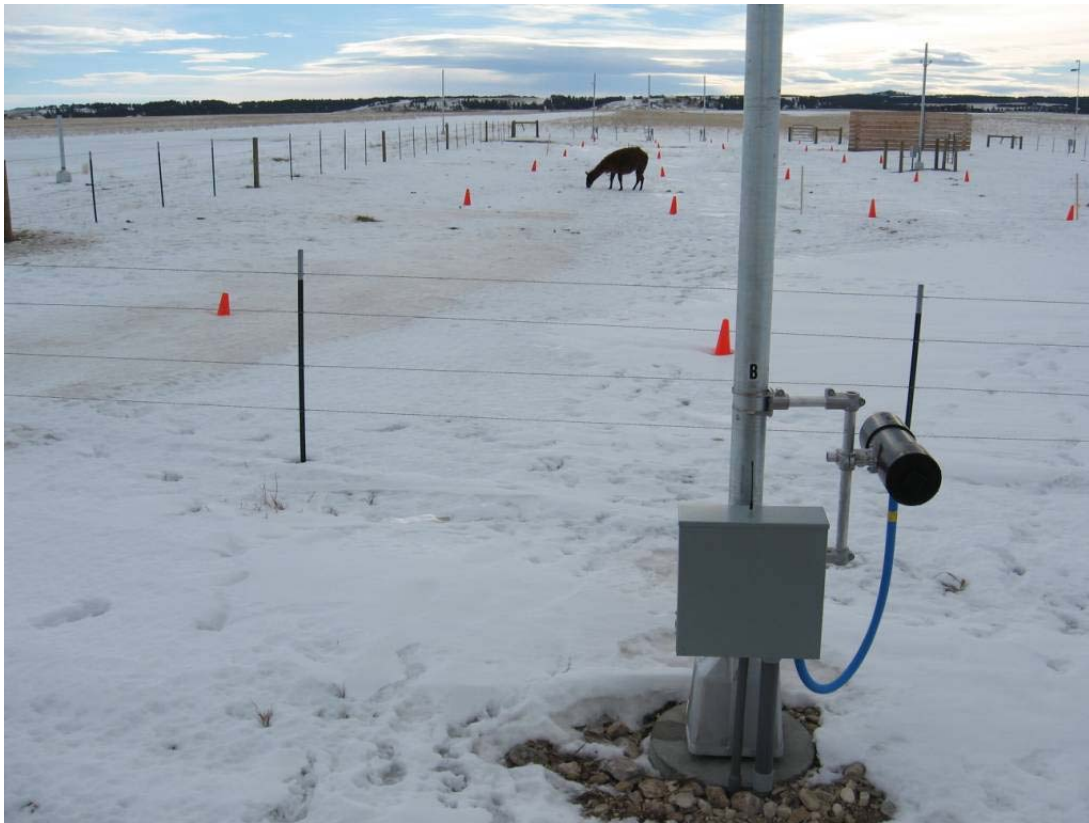
Figure 3.6: The detection zones and detection lines were marked with cones to be able to record the position of the animals (Photo: Marcel Huijser, WTI/MSU).

investigate the reliability of each system. Cones within the enclosure defined the detection zone for each system (Figure 3.6).

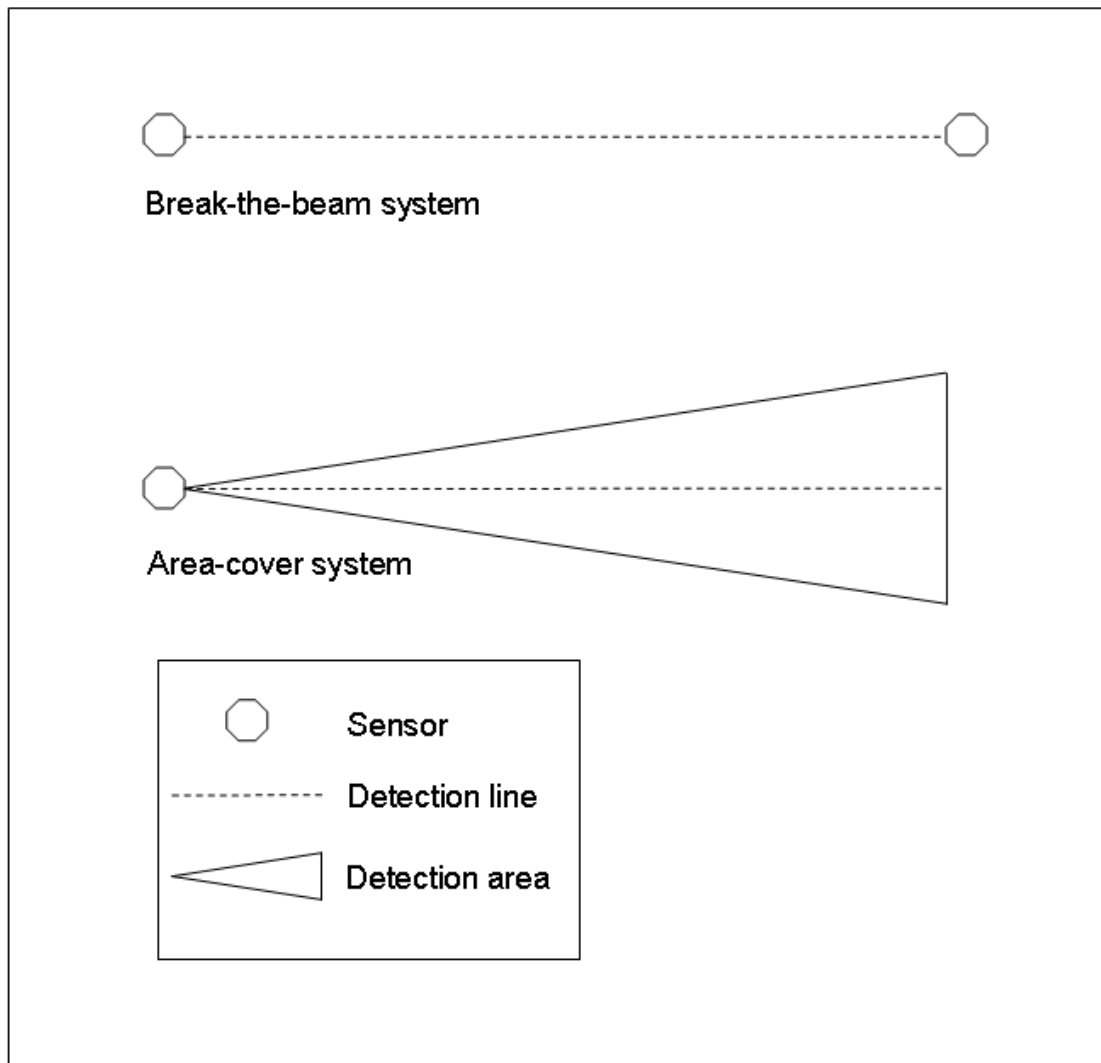
Figure 3.7: Schematic representation of break-the-beam and area-cover systems showing the detection line (or center line) for break-the-beam and area-cover systems, and the detection area for area-cover systems.

The detection area is the area within which area-cover systems should detect large animals, and the detection line is the line between sensors where break-the-beam systems should detect large animals (Figure 3.7). The detection areas and detection lines were indicated by the manufacturers and were marked with cones that were visible on the images from the individual cameras. Area-cover systems have relatively large, cone-shaped detection areas, whereas break-the-beam systems have a detection line that is linear or mostly linear in shape, although the STS 1 system that used microwave signals had a 3° angle from the transmitter, which resulted in a detection area that was 2.4 m (7.8 ft) wide at 91.4 m (300 ft) from the transmitter (Pers. com., Lloyd Salsman, Sensor Technologies & Systems, October 10, 2007).

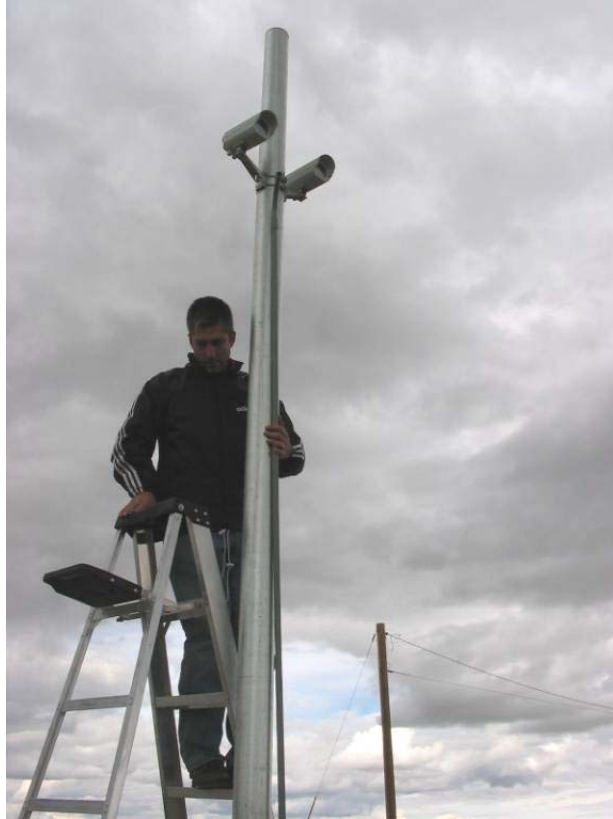
Figure 3.8: System 1 (Xtralis 7) and System 2 (Xtralis 5-6) mounted on the same pole (Photo: Matt Blank, WTI/MSU).

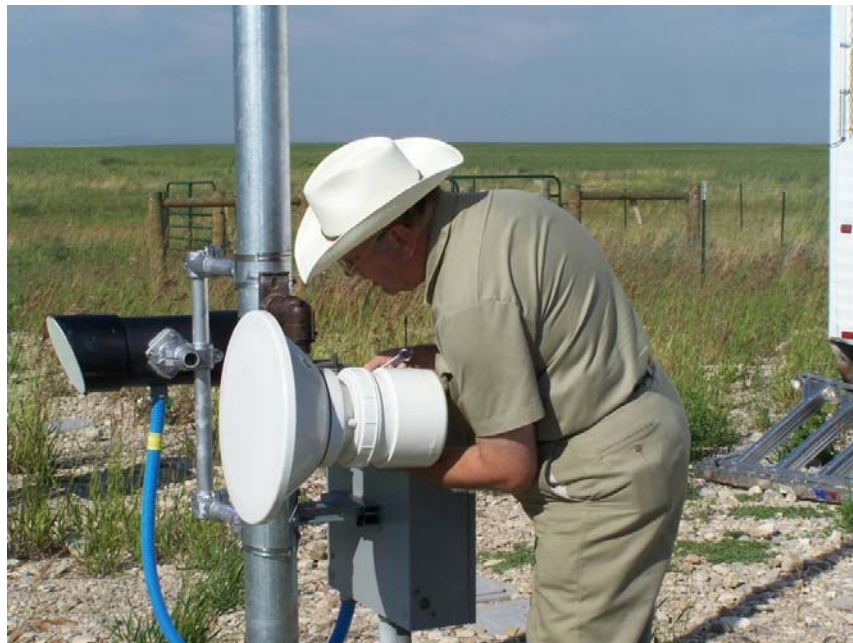
Figure 3.9: System 3 (STS I; black tube behind pole) and System 4 (STS II; white sensor in front of pole) mounted on the same pole (Photo: Tiffany Holland, WTI/MSU).

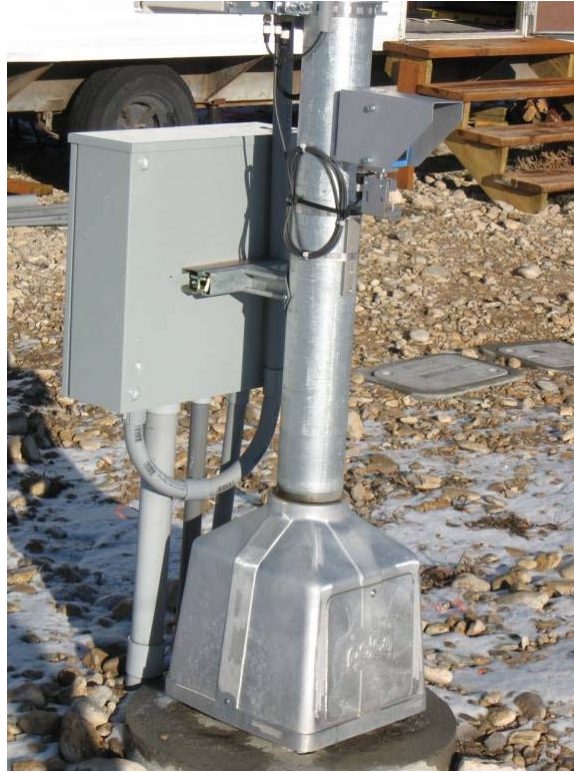
Figure 3.10: System 5 (Calonder Energy 1) (Photo: Marcel Huijser, WTI/MSU).

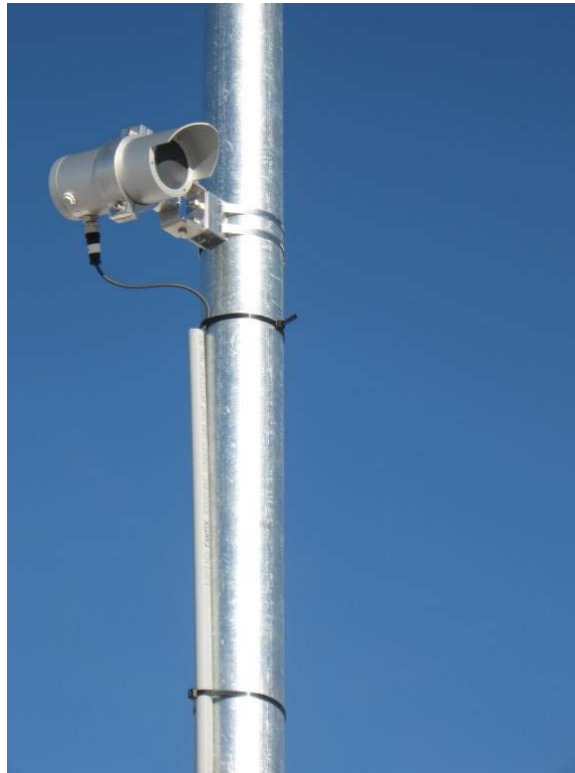
Figure 3.11: System 6 (Calonder Energy 2) (Photo: Marcel Huijser, WTI/MSU).

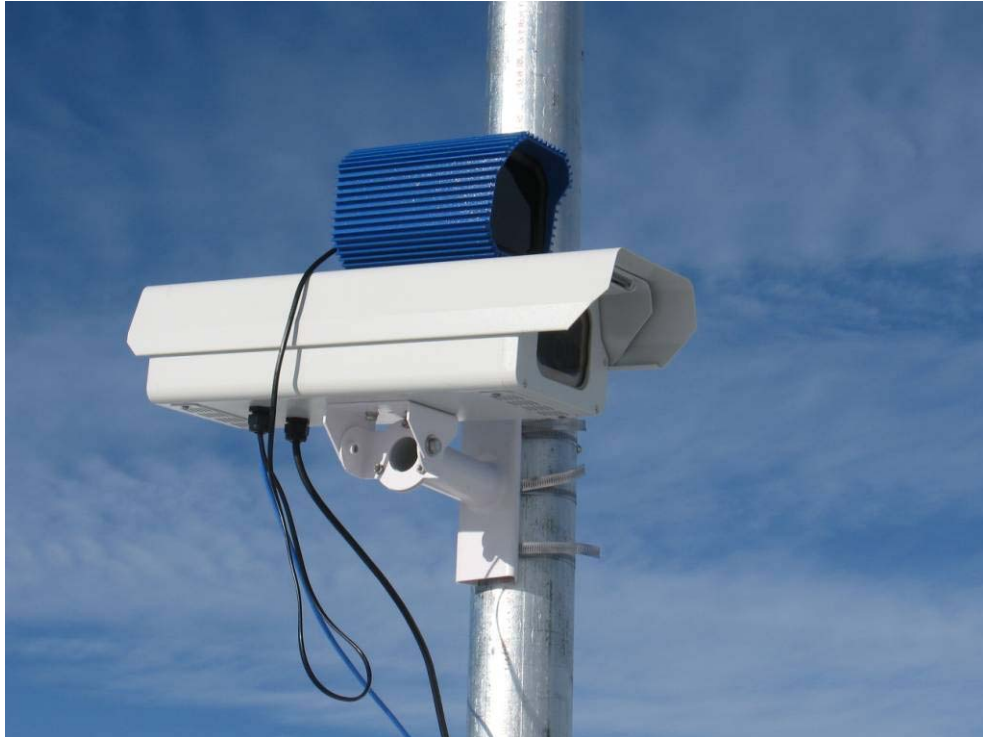
Figure 3.12: System 7 (Camrix) (Photo: Matt Blank, WTI/MSU).

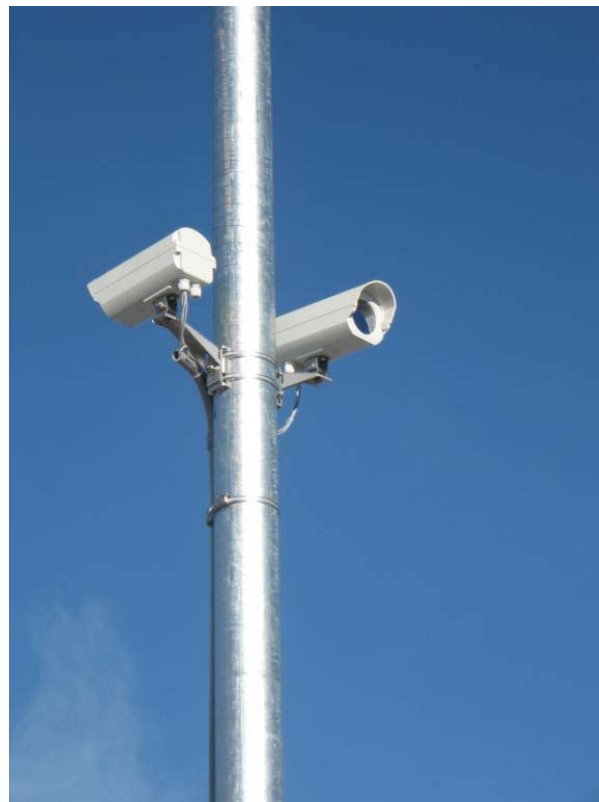
Figure 3.13: System 8 (Xtralis 1-2) (Photo: Marcel Huijser, WTI/MSU).

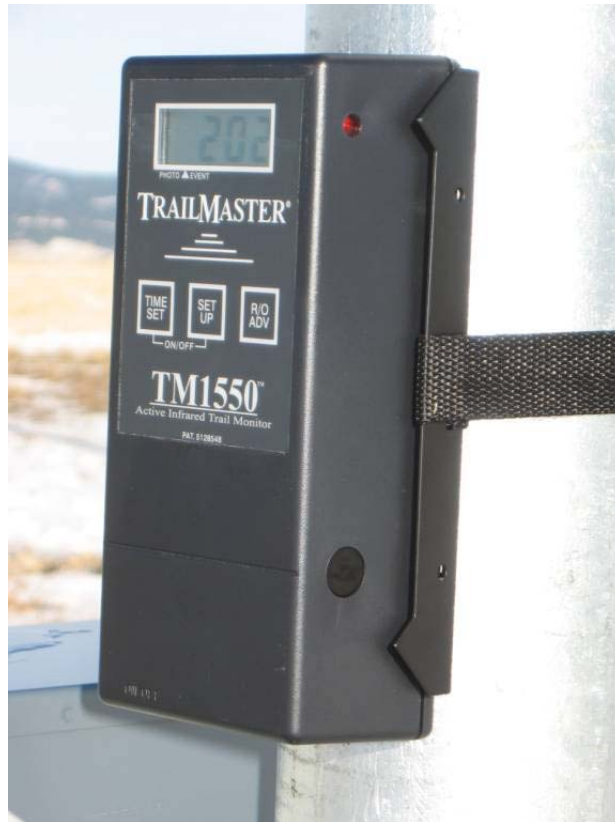
Figure 3.14: System 9 (Goodson) (Photo: Marcel Huijser, WTI/MSU).

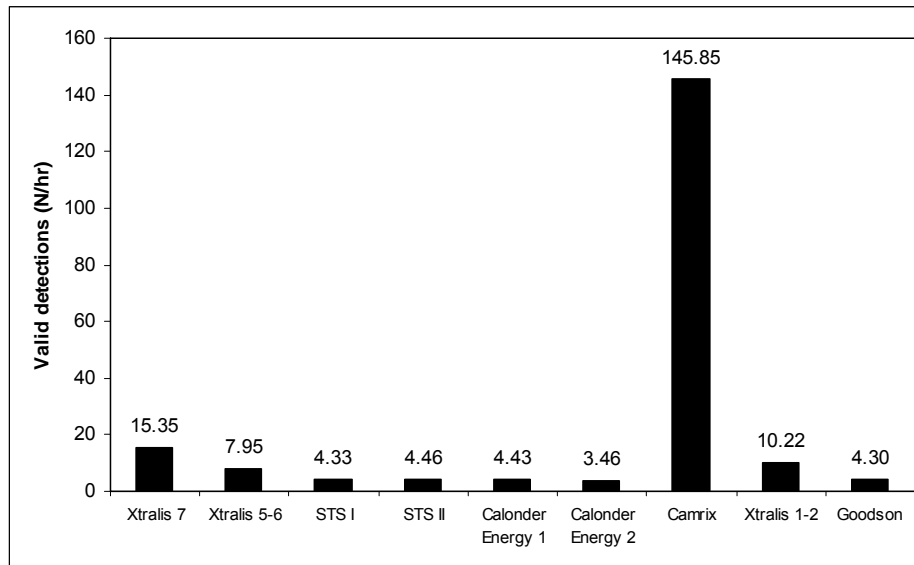
Figure 4.1: The average number of valid detections per hour for each system (Camrix: before (157.28) and after (72.79) system modification).

Figure 4.1 shows the average number of valid detections per hour for each system. Camrix had much higher numbers of valid detections compared to the other systems. The Xtralis systems also had relatively high numbers of valid detections. The other systems (STS I, STS II, Calonder Energy 1, Calonder Energy 2, and Goodson) had relatively low numbers of valid detections.

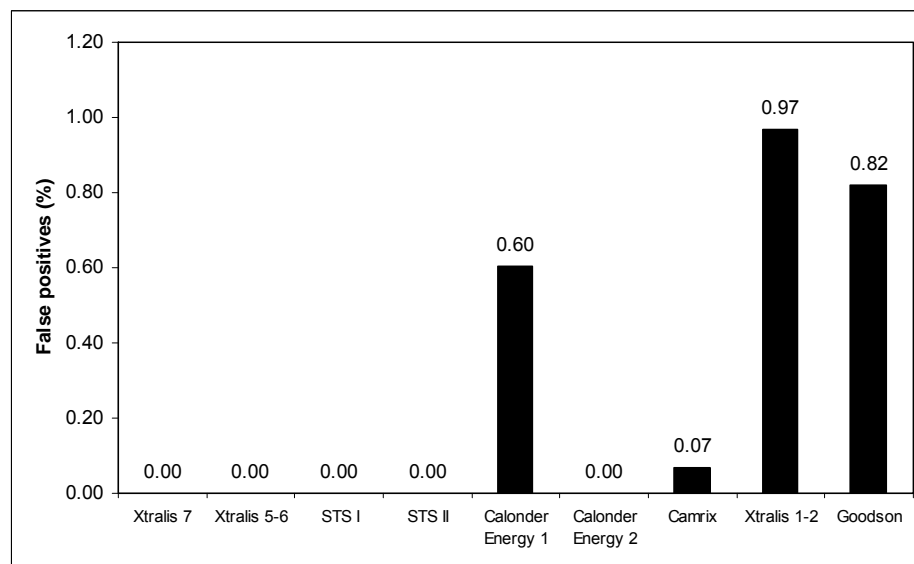
Figure 4.2: The percentage of false positives for each system (Camrix: before (0.07) and after (0.00) system modification).

The percentage of false positives was relatively low for all systems. Xtralis 1-2, Goodson, Calonder Energy 1, and Camrix had some false positives while the other systems had no false positives.

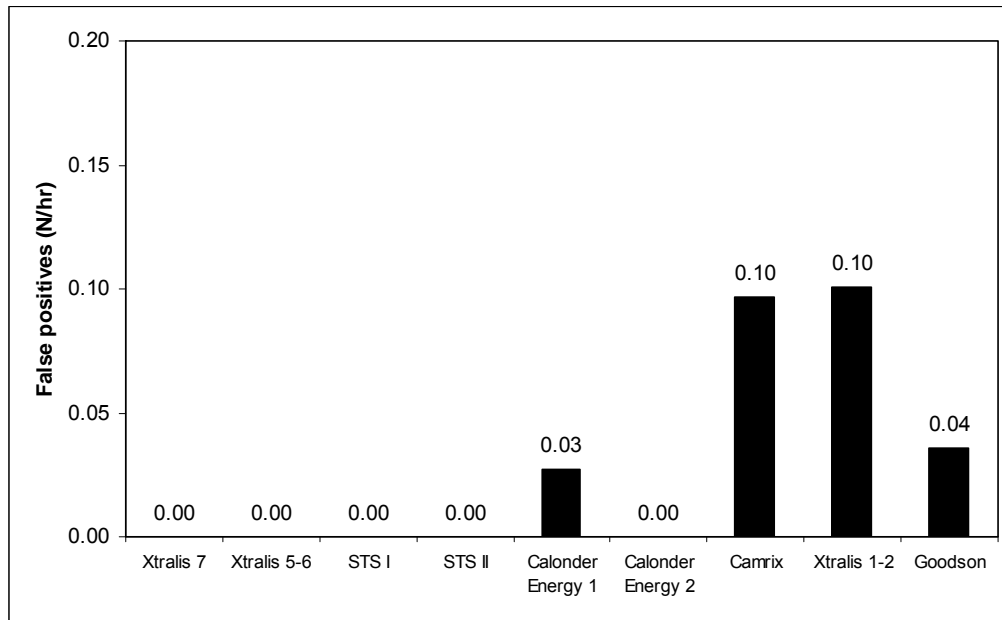
Figure 4.3: The average number of false positives per hour for each system (Camrix: before (0.11) and after (0.00) system modification).

The average number of false positives per hour was relatively low for all systems (Figure 4.3). Xtralis 1-2, Goodson, Calonder Energy 1, and Camrix all had fewer than 0.1 false positives per hour while the other systems had no false positives.

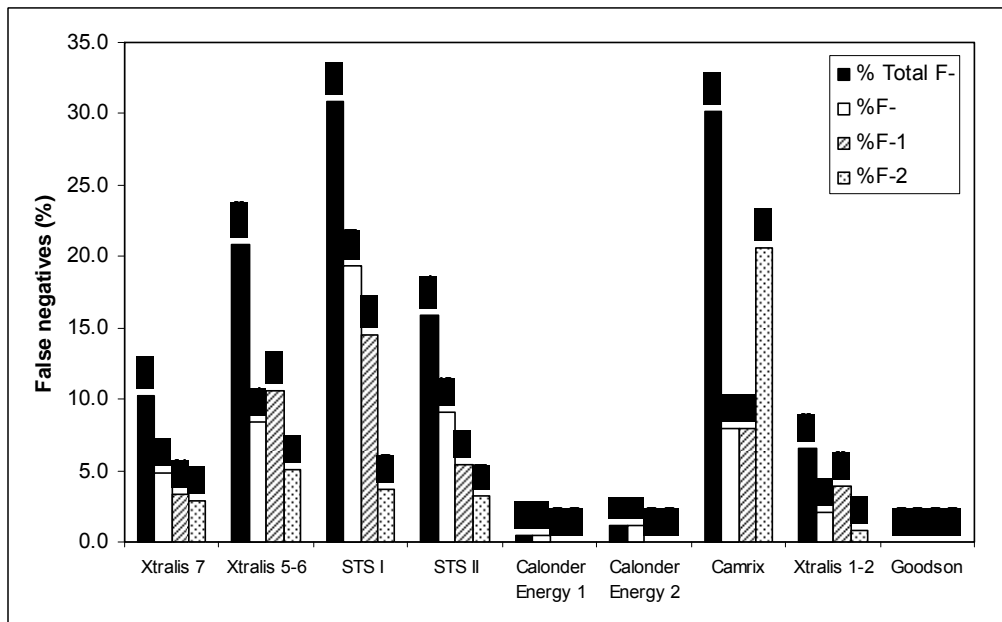
Figure 4.4: The percentage of false negatives for each system (Camrix: before (30.41; 7.00; 8.44; 21.22 respectively) and after (27.00; 20.59; 0.00; 10.00 respectively) system modification).

The percentage of false negatives was lowest for Calonder Energy 1, Calonder Energy 2, and Goodson (Figure 4.4). The percentage of false negatives was highest for STS I and Camrix.

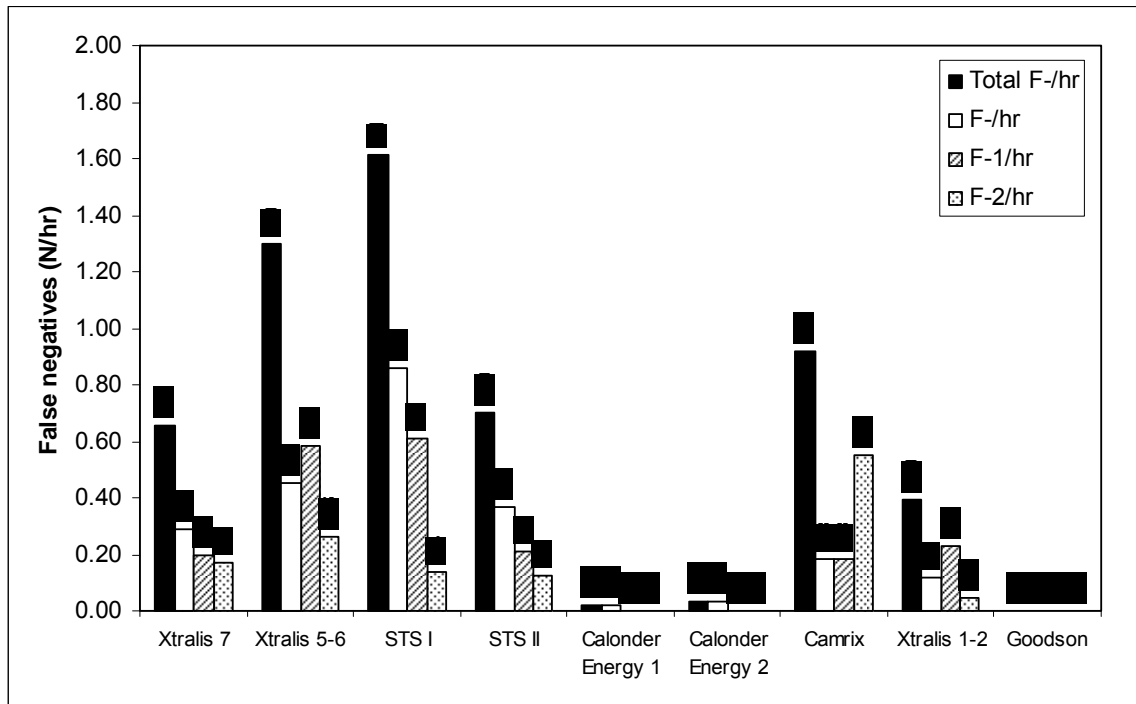
Figure 4.5: The average number of false negatives per hour for each system (Camrix: before (1.01; 0.17; 0.21; 0.62 respectively) and after (0.36; 0.25; 0.00; 0.11 respectively) system modification).

The average number of false negatives per hour was lowest for Calonder Energy 1, Calonder Energy 2, and Goodson (Figure 4.5). The highest values occurred for STS I and Xtralis 1-2.

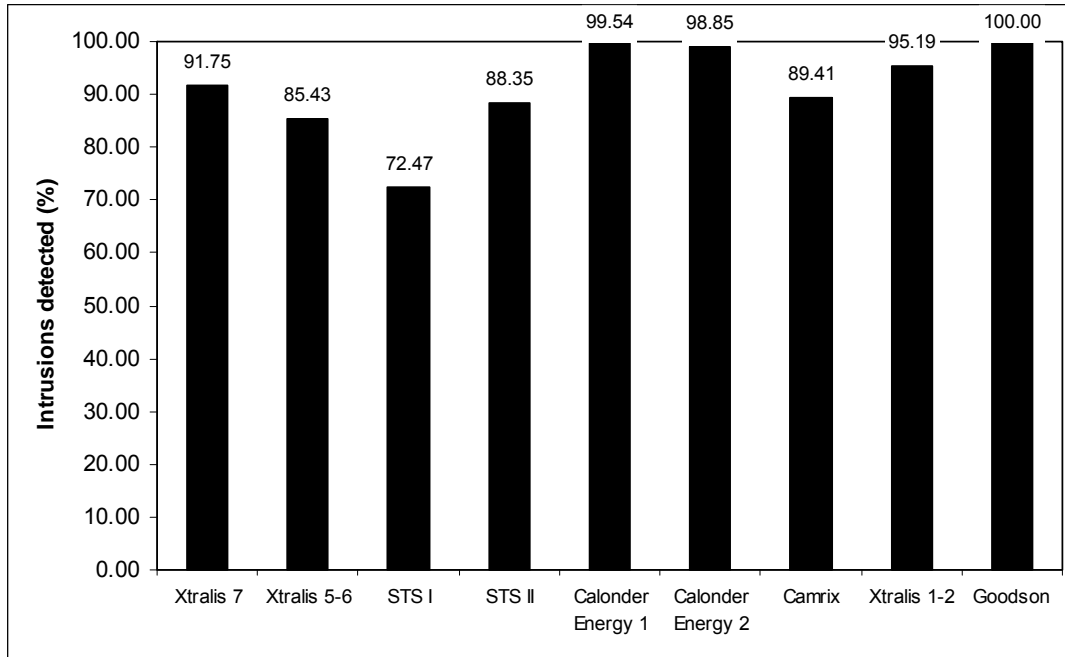
Figure 4.6: The percentage of intrusions that were detected for each system (Camrix: before (89.33; additional analysis 81.82) and after (90.24; additional analysis 75.51) system modification).

The following systems detected all or nearly all intrusions (i.e., animal movements across the detection line): Goodson, Calonder Energy 1, and Calonder Energy 2 (Figure 4.6). STS I showed the lowest detection percentage (Figure 4.6). For Camrix an additional analysis that included the detection area (see section 5.3) showed this system detected 81.2 percent of all intrusions in the detection area.

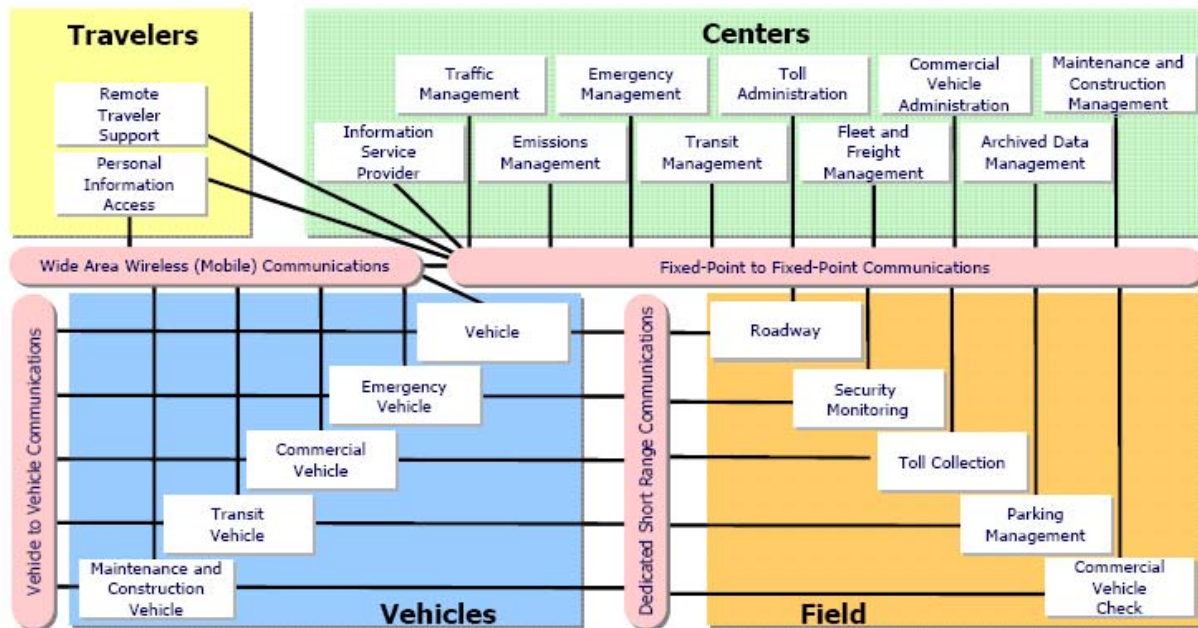
Figure 7.1: Physical Architecture (Source: USDOT 2007).

The physical architecture shows how different subsystems (i.e., travelers, field elements, centers, and vehicles) may be interconnected. The physical architecture is not a detailed design, but shows the current and potential communication links so that systems can be integrated and share communications infrastructure. From a high level, the physical architecture is commonly represented by the “sausage diagram” (Figure 7.1).

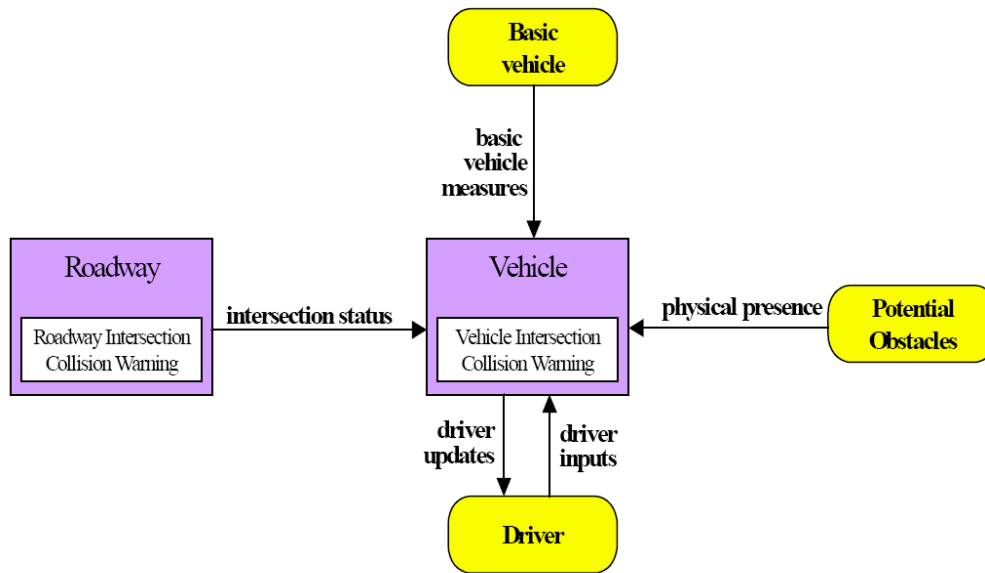
Figure 7.2: Market Package Example (Source: USDOT, 2002).

vehicle,” “potential obstacles,” and “driver” are external elements that participate in the market package. The arrows show the information flows.

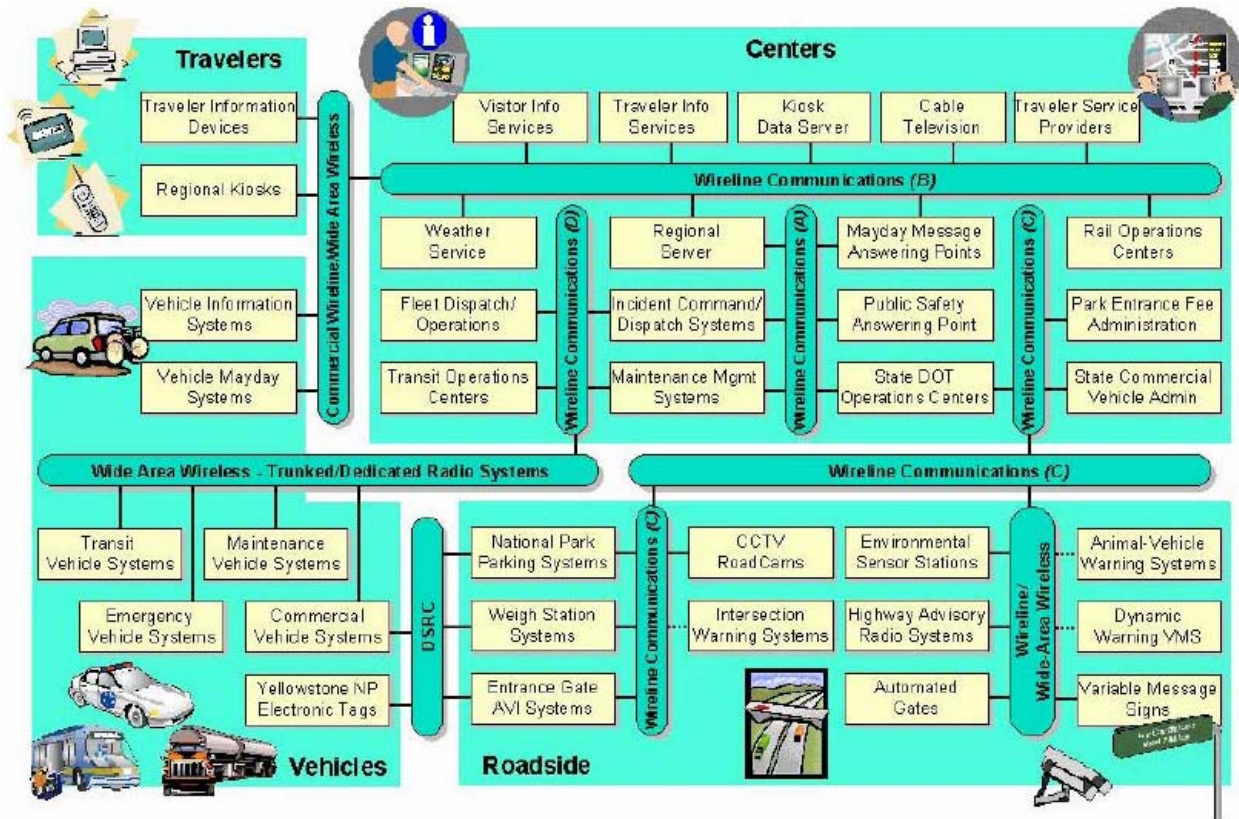
Figure 7.3: Sausage Diagram for GYRITS Regional Architecture (Source: Ice, 1999).

Figure 7.3 shows the physical architecture for the region as defined in the GYRITS architecture. Notice “animal vehicle warning system” is depicted in the roadside subsystem. The physical architecture provides flexibility of communication infrastructure (wireless or wireline) depending on the specific implementation.

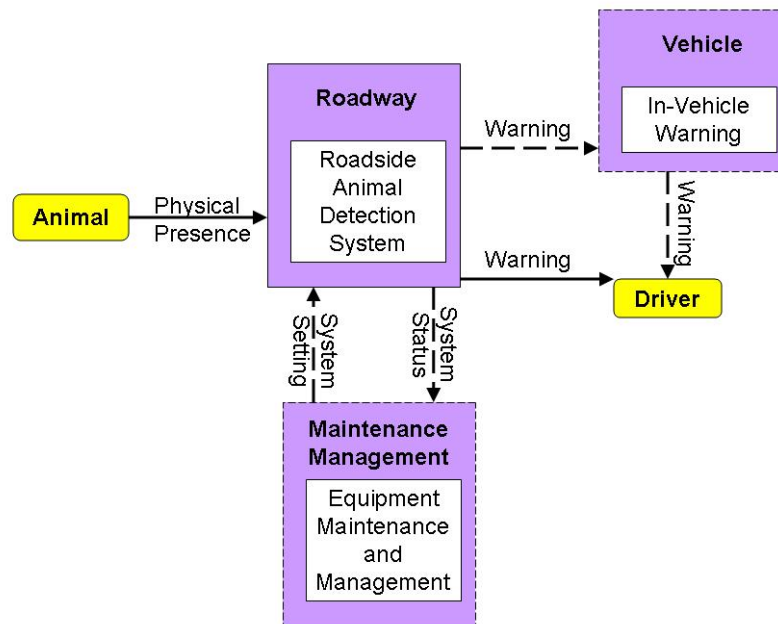
Figure 7.4: Animal detection system Market Package.

Figure 7.4 shows the communication link between the roadside and a center, consistent with the national architecture. The system could be monitored by a traffic management center. The basic system is envisioned to warn the driver through roadside signing. If in-vehicle warning systems become more prevalent, the system could communicate with the vehicle to provide in-vehicle warning.

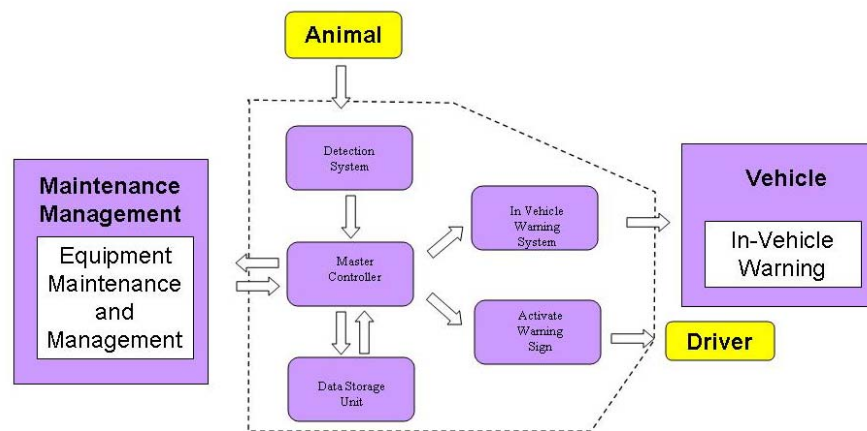
Figure 7.5: Potential equipment package.

Figure 7.5 shows how each piece of the animal detection system equipment package, inside the dashed line, connects to each other and how the entire equipment package connects with the other elements of the market package. Within the equipment packages there is a wide variety of equipment to use, and different ways to get the information to the driver on the road. For example the detection system could be a motion sensor with infrared to detect the animals, or it could use a radar detection system. The detection system will provide data to the master controller. The data can be in terms of actual presence detection, or a raw signal that is processed by the master controller. The master controller must activate the warning sign when a presence is detected. A data storage unit is optional, but useful for evaluating and improving the system. The data storage unit will record the time and location of detections for future download and analysis.

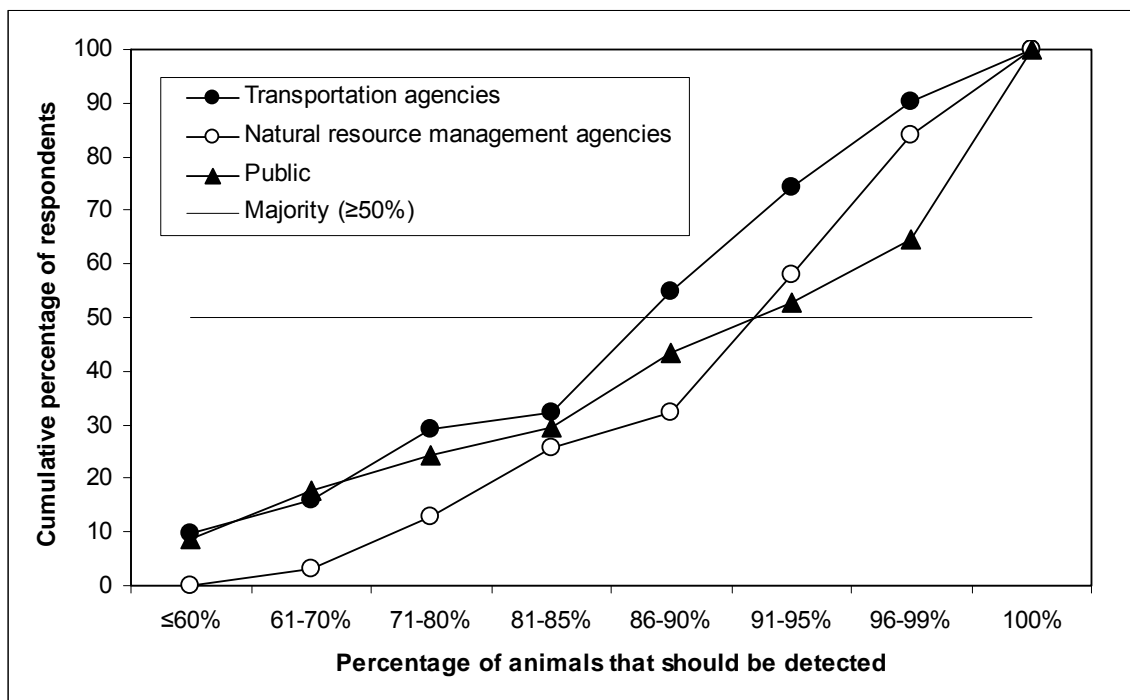
Figure 8.2: The percentage of large animals approaching the road that survey respondents said should be detected by animal detection systems. The number of respondents included in the analysis was 31 for transportation agencies, 31 for natural resource management agencies, and 136 for the public.

The majority ($\geq 50\%$) of all three stakeholder groups would be satisfied with animal detection systems detecting 91–95% or more of all large animals that approach the road (Figure 8.2).

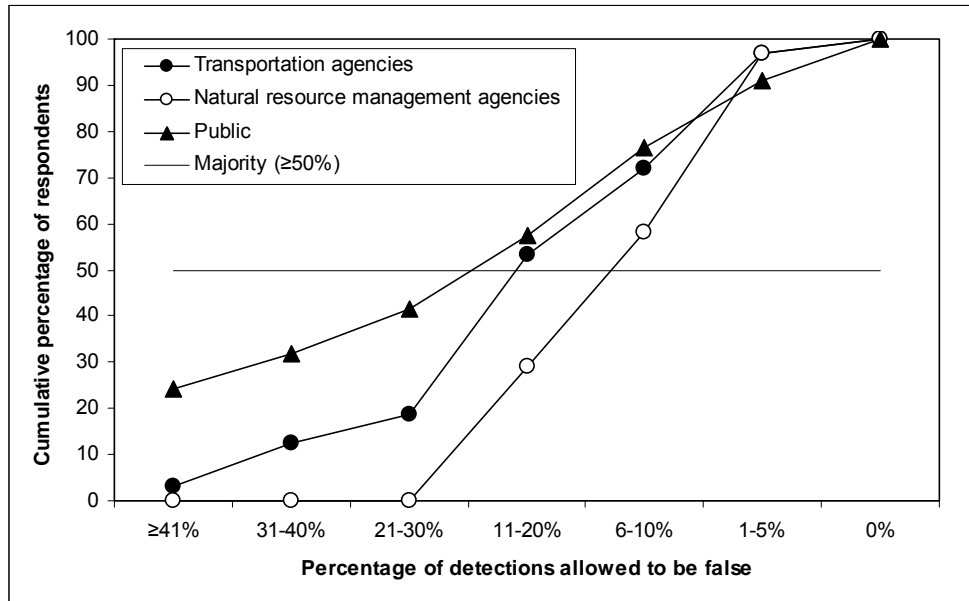
Figure 8.3: The percentage of detections by animal detection systems respondents would allow to be false. The number of respondents included in the analysis was 32 for transportation agencies, 31 for natural resource management agencies, and 132 for the public.

The majority ($\geq 50\%$) of all three stakeholder groups would be satisfied with animal detection systems for which 6–10% or less of all detections be are false (Figure 8.3).

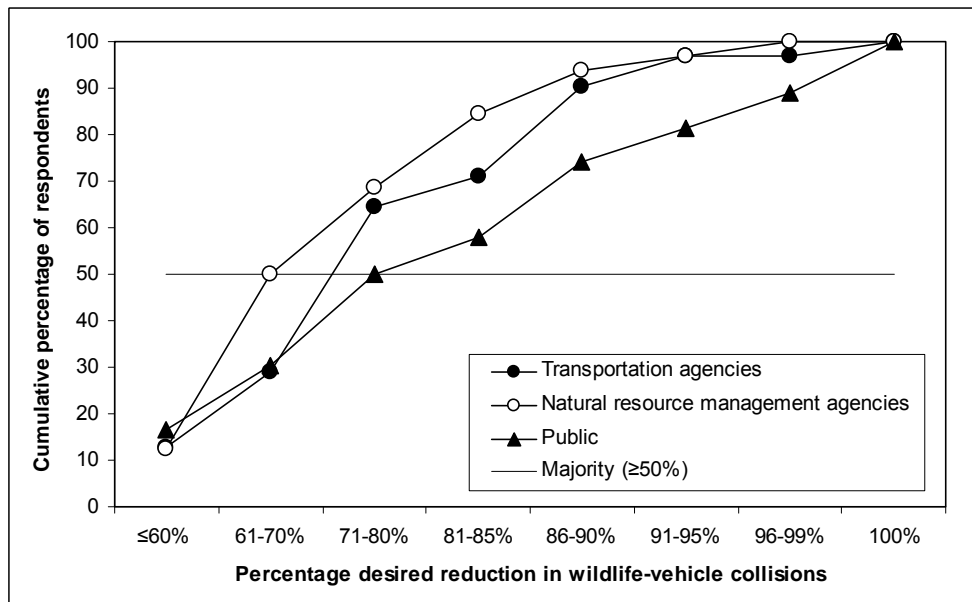
Figure 8.4: The percentage reduction in wildlife–vehicle collisions that is considered desirable. The number of respondents included in the analysis was 31 for transportation agencies, 32 for natural resource management agencies, and 128 for the public.

The majority ($\geq 50\%$) of all three stakeholder groups would be satisfied with animal detection systems that provide a reduction of 71–80% or more in wildlife–vehicle collisions (Figure 8.4).

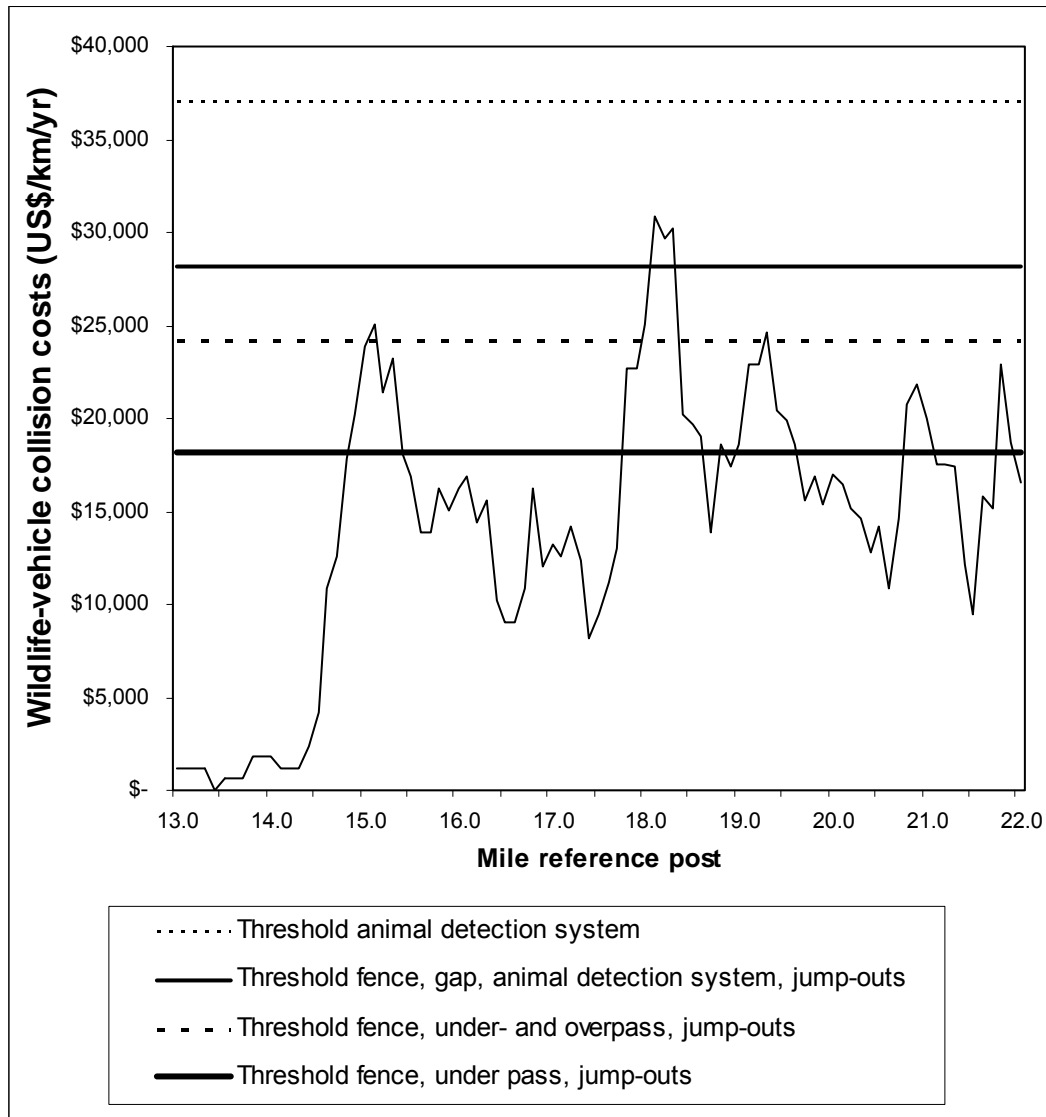
I-90 DeBorgia West and I-90 DeBorgia East combined

Figure 9.8: I-90 DeBorgia East and West. The costs (in 2007 US\$) associated with wildlife-vehicle collisions (white-tailed deer, mule deer, elk, moose, and 7 black bears and 1 mountain lion (black bears and mountain lions were estimated to have equal cost as deer) along the 4-lane I-90 (mi reference posts 13.0-22.0) per year (average 1998-2008), and the threshold values (at 3% discount rate) that need to be met in order to have the benefits of individual mitigation measures exceed the costs over a 75 year long time period. Note that the costs at each 0.1 mi concerned and five adjacent 0.1 mi units were summed (0.6 mi = 1 km) to estimate the costs per kilometer.
