**The Comparison of Animal Detection Systems in a Test-Bed:
A Quantitative Comparison of System Reliability and Experiences
with Operation and Maintenance**

Final report

Federal Highway Administration

Montana Department of Transportation

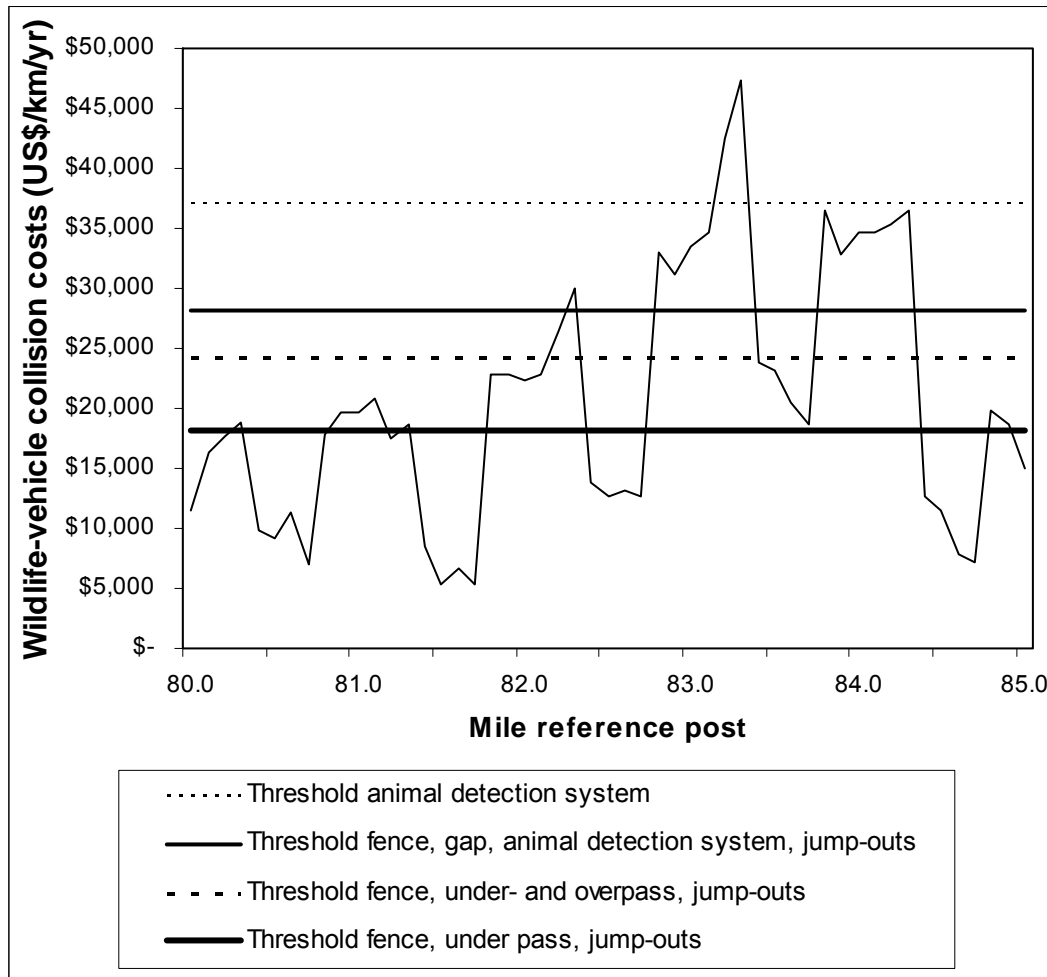
I-90 Ninemile

Figure 9.9: I-90 Ninemile. The costs (in 2007 US\$) associated with wildlife-vehicle collisions (white-tailed deer, mule deer, and 2 black bears and 1 wolf (black bears and wolves were estimated to have equal cost as deer) along the 4-lane I-90 (mi reference posts 80.0-85.0) per year (average 1998-2008), and the threshold values (at 3% discount rate) that need to be met in order to have the benefits of individual mitigation measures exceed the costs over a 75 year long time period. Note that the costs at each 0.1 mi concerned and five adjacent 0.1 mi units were summed (0.6 mi = 1 km) to estimate the costs per kilometer.

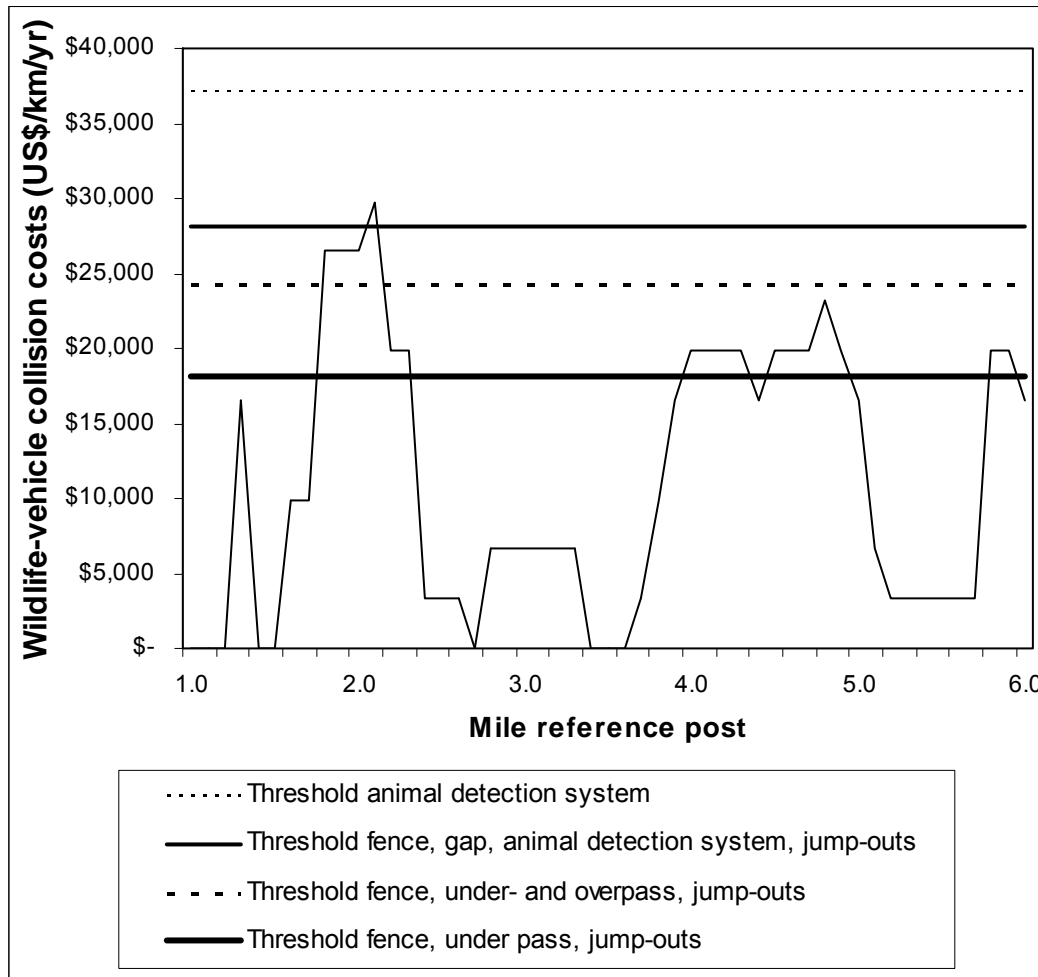
Hwy 206 Kalispell

Figure 9.10: Hwy 206 Kalispell. The costs (in 2007 US\$) associated with wildlife-vehicle collisions (white-tailed deer, mule deer, and 3 mountain lions (mountain lions were estimated to have equal cost as deer) along the 2-lane Hwy 206 (mi reference posts 1.0-6.0) per year (average 2005-2006), and the threshold values (at 3% discount rate) that need to be met in order to have the benefits of individual mitigation measures exceed the costs over a 75 year long time period. Note that the costs at each 0.1 mi concerned and five adjacent 0.1 mi units were summed (0.6 mi = 1 km) to estimate the costs per kilometer.

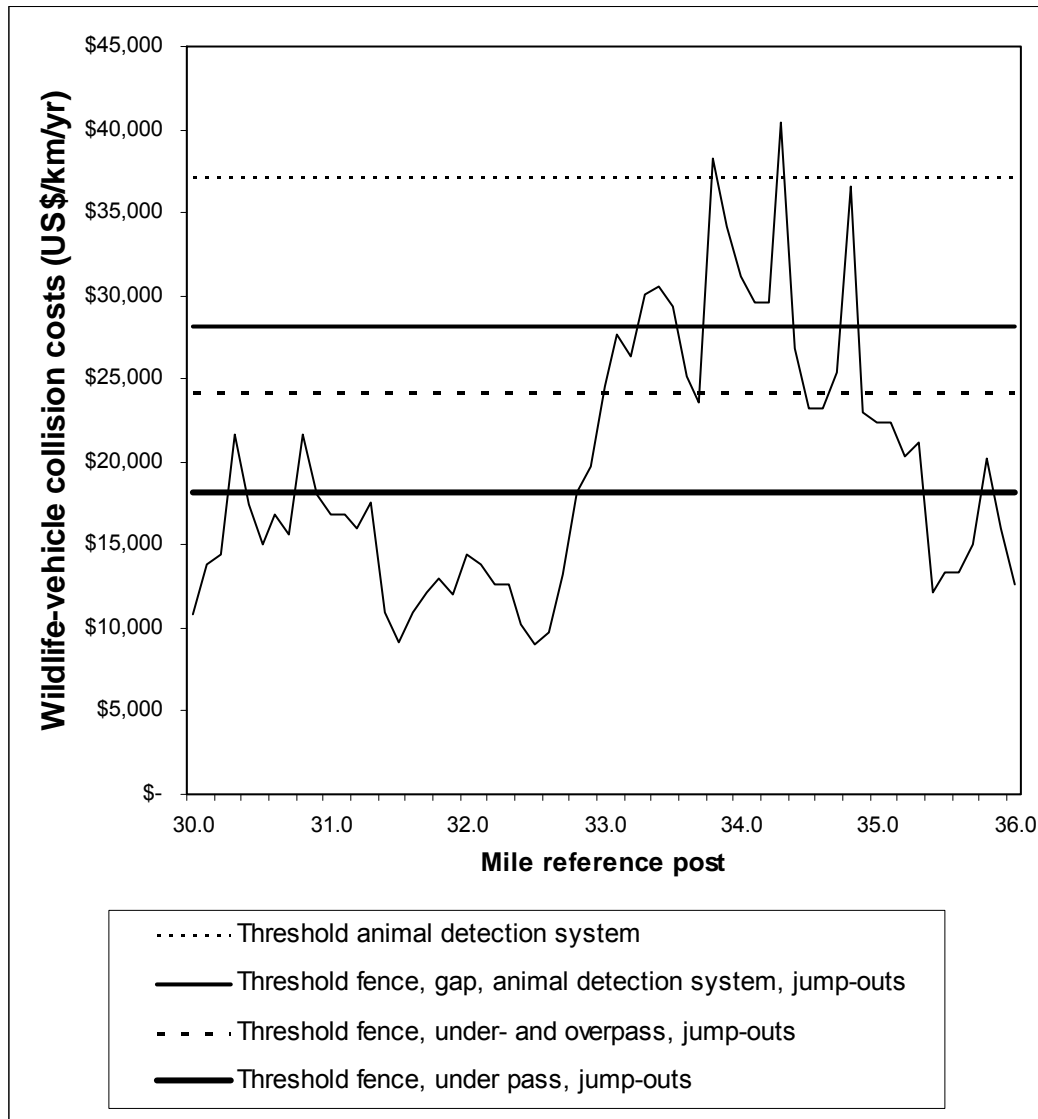
MT Hwy 200 Clearwater Jct

Figure 9.11: MT Hwy 200 Clearwater Jct. The costs (in 2007 US\$) associated with wildlife-vehicle collisions (white-tailed deer, mule deer, elk, and 2 black bears and 1 mountain lion (black bears and mountain lion were estimated to have equal cost as deer) along the 2-lane MT Hwy 200 (mi reference posts 30.0-36.0) per year (average 1998-2008), and the threshold values (at 3% discount rate) that need to be met in order to have the benefits of individual mitigation measures exceed the costs over a 75 year long time period. Note that the costs at each 0.1 mi concerned and five adjacent 0.1 mi units were summed (0.6 mi = 1 km) to estimate the costs per kilometer.

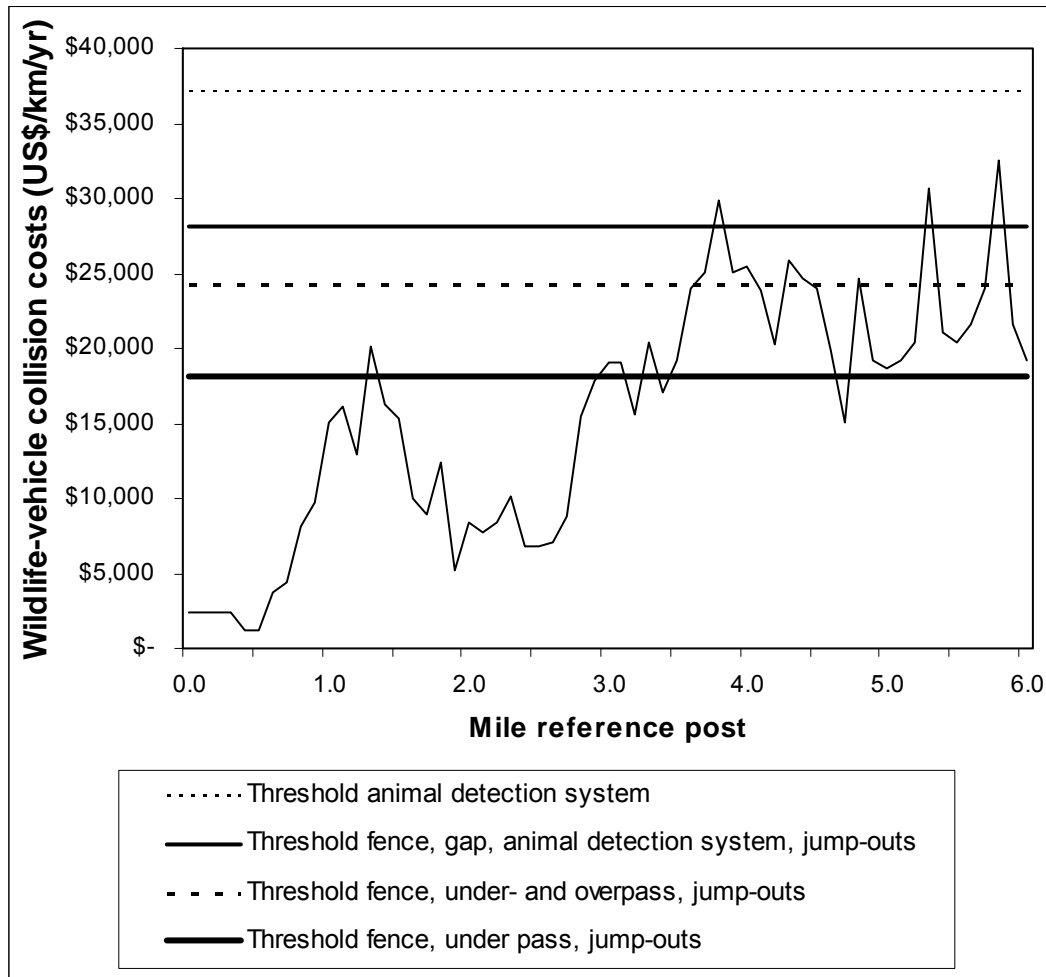
MT Hwy 83 Clearwater Jct

Figure 9.12: MT Hwy 83 Clearwater Jct. The costs (in 2007 US\$) associated with wildlife-vehicle collisions (white-tailed deer, mule deer, elk, 1 mountain lion (mountain lion were estimated to have equal cost as deer) along the 2-lane MT Hwy 83 (mi reference posts 0.0-6.0) per year (average 1998–2008), and the threshold values (at 3% discount rate) that need to be met in order to have the benefits of individual mitigation measures exceed the costs over a 75 year long time period. Note that the costs at each 0.1 mi concerned and five adjacent 0.1 mi units were summed (0.6 mi = 1 km) to estimate the costs per kilometer.

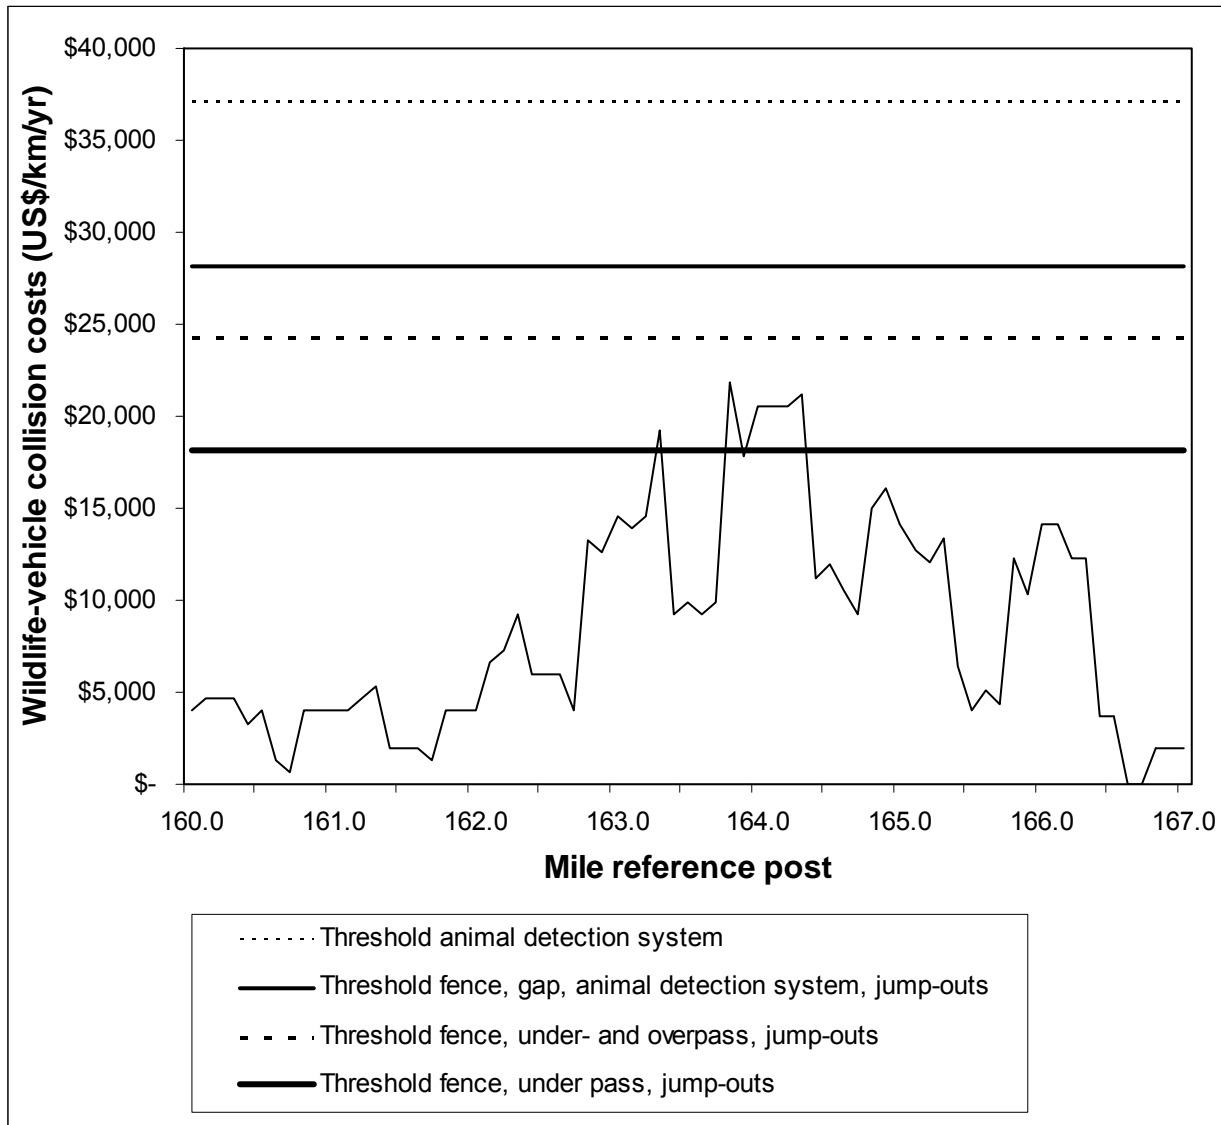
I-15 Boulder

Figure 9.13: I-15 Boulder. The costs (in 2007 US\$) associated with wildlife-vehicle collisions (deer and elk) along the 4-lane I-15 (mi reference posts 160.0-167.0) per year (average 1998–2007), and the threshold values (at 3% discount rate) that need to be met in order to have the benefits of individual mitigation measures exceed the costs over a 75 year long time period. Note that the costs at each 0.1 mi concerned and five adjacent 0.1 mi units were summed (0.6 mi = 1 km) to estimate the costs per kilometer.
